**PRIOR RECLAMATION INSPECTION REPORT
AND
RECOMMENDATION FOR RELEASE OR PERMIT
REQUIREMENT**

United Nuclear Corporation - Anna Lee Mine

**New Mexico Energy, Minerals and Natural Resources Department
Mining and Minerals Division
Mining Act Reclamation Bureau**

August 3, 1995

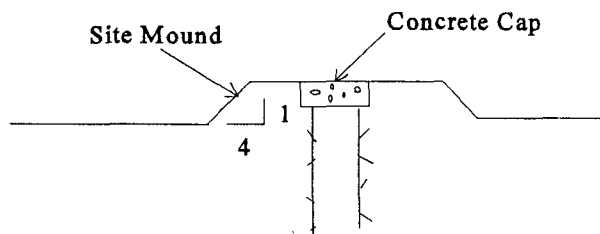
Figure 3. Cross Section of Site

A barbed wire fence surrounded the site. All structures, trash or junk had been removed from the site. There were no piles or accumulations of toxic or waste material on the site. There were no erosion features. Photos documenting vegetation and general condition of the site are in Appendix B. The photos are described in Table I. The mine shaft had been backfilled with nontoxic mine waste material and capped with a Concrete Slab approximately 20 foot square and 4 feet thick (See Figure 3). The concrete cap was not covered with soil. Three feet of soil had been removed from the area around the site. The soil depth within the site was, therefore, at least three feet deep. The area had been seeded last fall but vegetation was very sparse. Crested Wheatgrass and some perennials were the only species identified. Crested wheat was a constituent in the seed mix.
